The Effect Of Distribution Systems On Household Drinking Water Quality In Addis Ababa, Ethiopia, and Christchurch, New Zealand

A thesis submitted in partial fulfilment of the requirements for
the Degree of Master of Water Resource Management at the
University of Canterbury

Dawit Kidane Mekonnen

2015

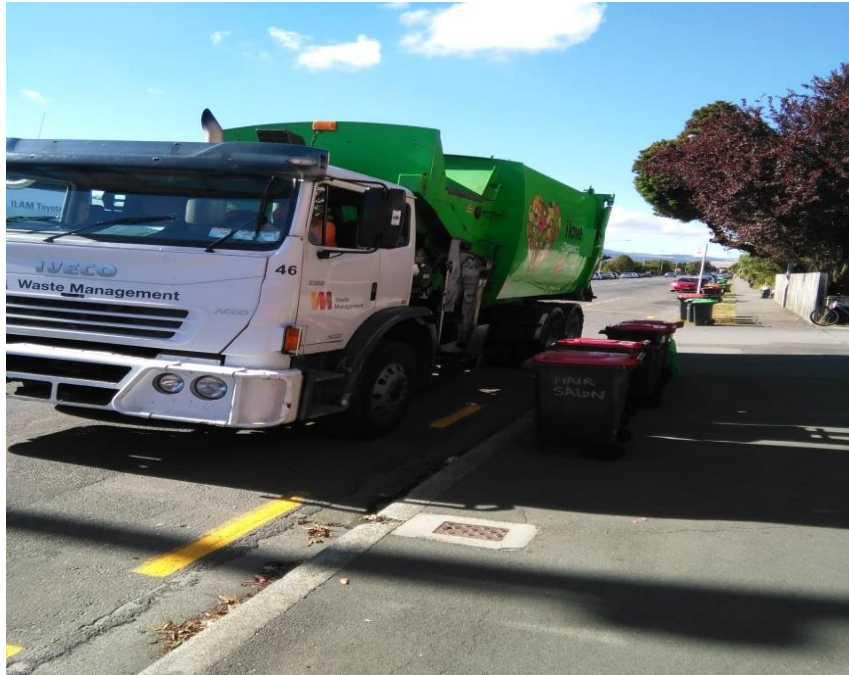
Source: Photo taken during field

Figure 1.3: A truck collecting solid waste from a kerbside in Christchurch City. This photo shows that the waste management system used by the Christchurch City Council is keeping the city tidy.

Christchurch has a high standard of sanitation within the city. This is partly due to effective household waste management practices. Household waste is collected using three different rubbish bins labelled with red, green and yellow lids. The red bin is used to collect non-recyclable and non-organic rubbish. The green bin is to collect organics such as food and garden waste. The yellow bin is used to collect recycling wastes such as paper, cardboard, glass, metal and plastic containers. These wastes are collected weekly by the Christchurch City Council (CCC) and by private and commercial operators. It is taken to the regional landfill which is located in Kate Valley for disposal (Figure 1.3).

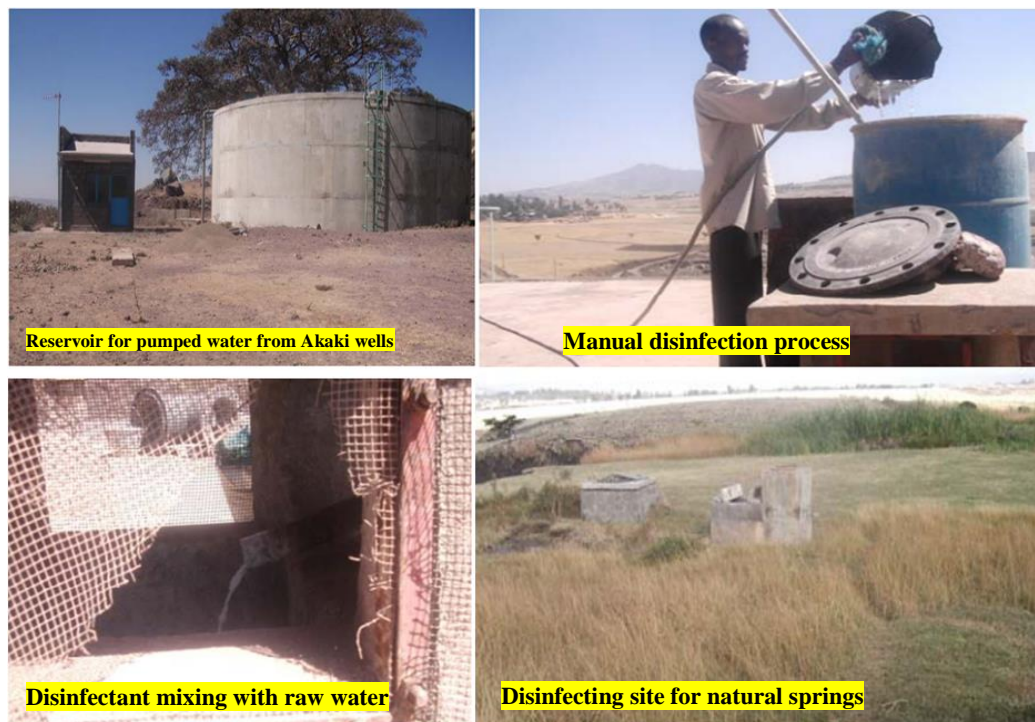
Initially, groundwater from the Akaki well field is pumped into storage reservoirs. Depending on the waters background quality, it may be first disinfected in the reservoirs before it is pumped into the distribution system for public use. In general, all water sourced from these wells is disinfected manually by the addition of powdered chlorine (as shown in Figure 1.6) (Birhanu, 2007).

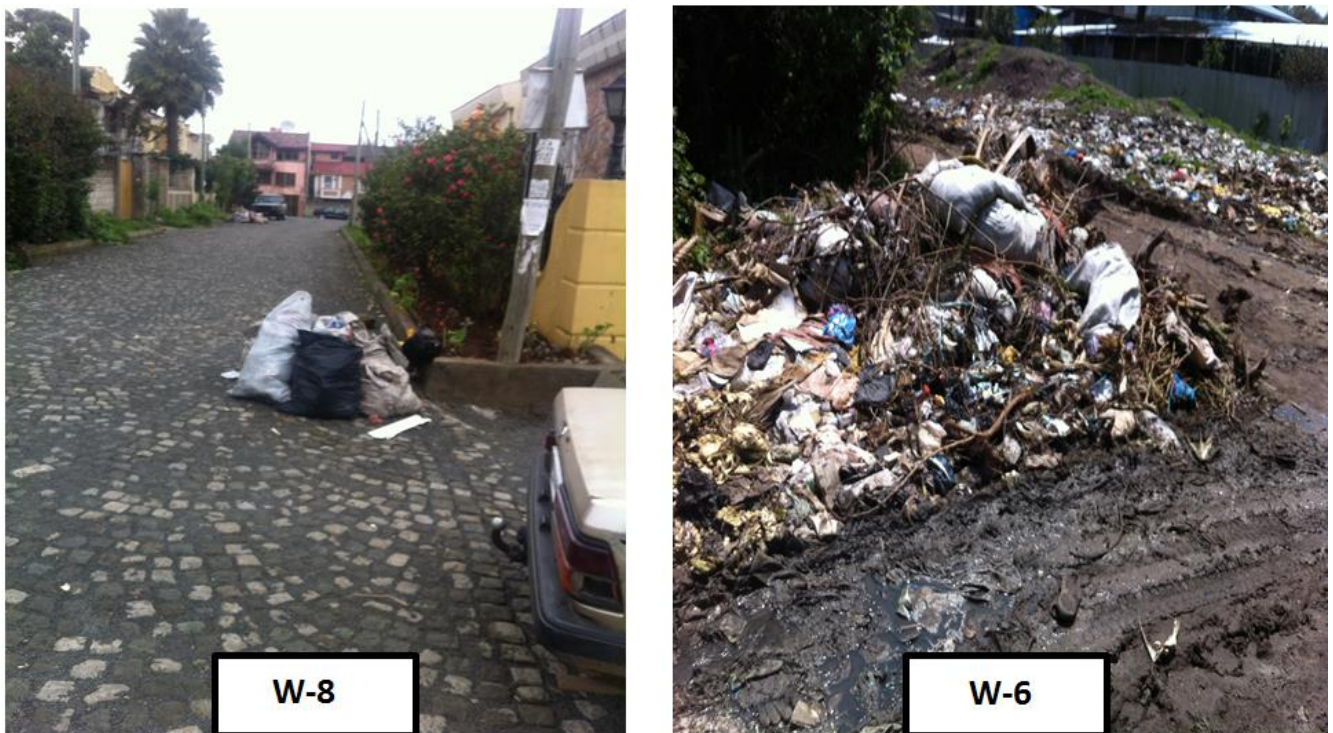
Source: Photo taken during field

Figure 1.9: Photographs of kerbside rubbish collection taken in W-8 and W-6 in Addis Ababa. The waste collection in W-8 is hygienic and organised. Waste disposal in W-6 is uncontrolled.

Figure 1.9 shows examples of the different ways waste is disposed of in Addis Ababa. Most household waste is collected using two wheeled containers that are operated manually. These are then transported to trucks which take it to a landfill.

Cities that do not have adequate wastewater networks and management practices will have issues with supplying safe drinking water. In Addis Ababa, the majority of houses and business centres (such as hotels, garages and car washes) dispose of their grey-water into the drainage systems. However, these drainage systems are ineffective in many areas. During the wet season, solid wastes mixed with rainfall can flow into cross-connected water supply systems (Figure 1.9 and Figure 1.10). This can contaminate household drinking water.

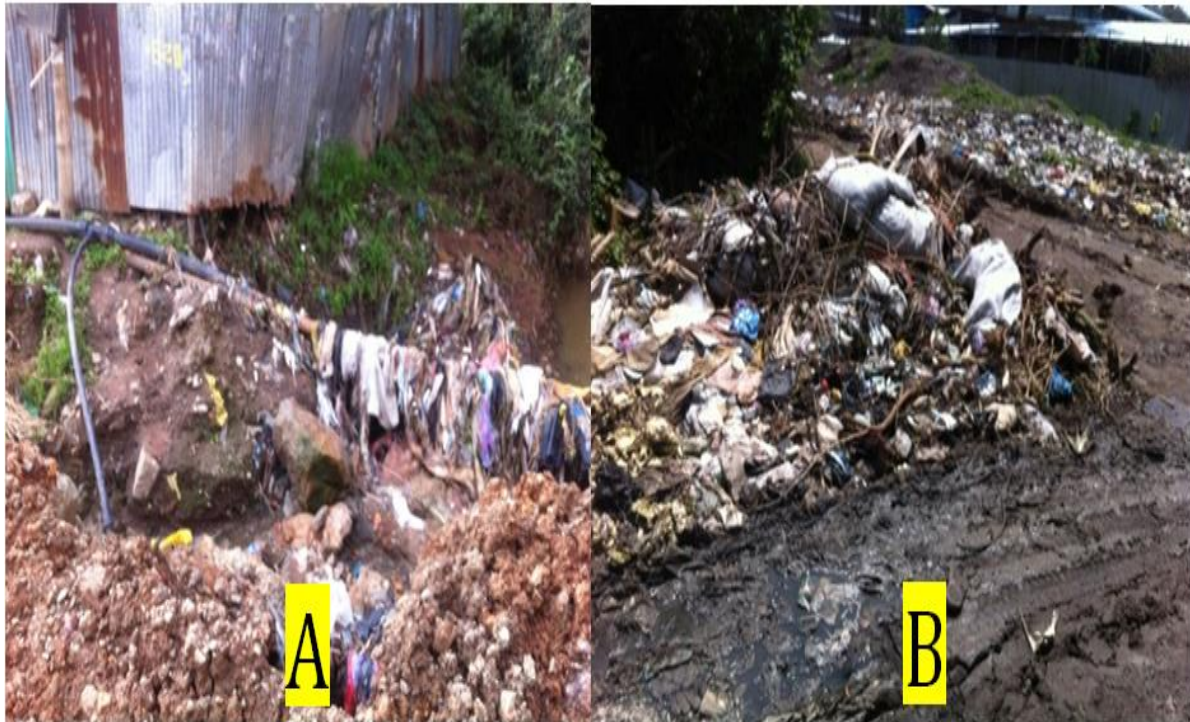
Figure 1.10: Uncollected solid wastes degrade the environment and reduce the sanitary conditions of the city. (A) Solid waste trapped by a pipe crossing a river (B) Solid waste left uncollected.

on the river banks of the city (UN-HABITAT, 2013). This solid waste pollutes water in these environments (Figure 1.10).

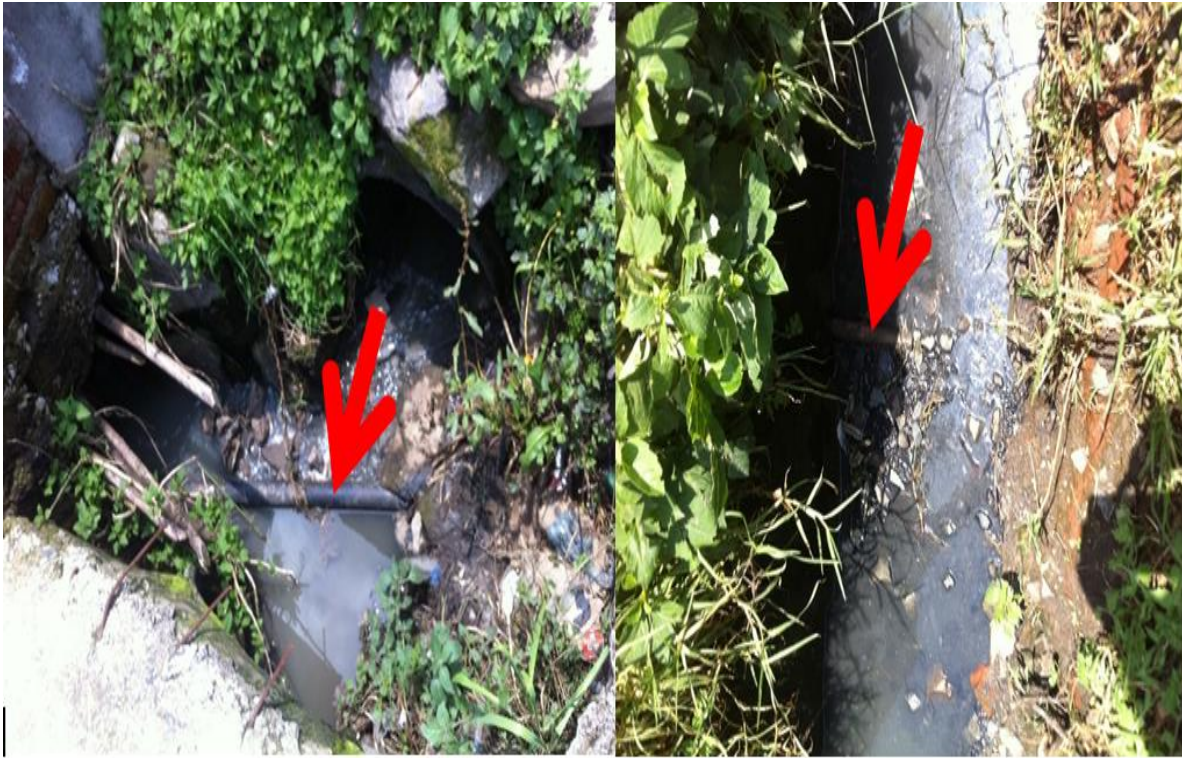
Source: Photo taken during field

Figure 1.11: The nature of the water distribution infrastructure in most old dwellings. The red arrows indicate pipelines crossing drainage ditches.

The combination of the degraded infrastructure and a cross-connected distribution system may provide a favourable environment for drinking water contamination to occur. Considering the poor environmental conditions in many districts of the city (Figure 1.11), there are many

The study in Addis Ababa City was conducted on two specific districts of Bole subcity namely: Wereda-6 and Wereda-8, and also the wider Bole subcity itself. Wereda-6 is among the old districts which is occupied and dominated by slum dwellers, and the nature of water supply distribution system is very old with poor waste management system as shown in Figure 1.9, Figure 1.10 and Figure 1.11. Wereda-8 is occupied by wealthy residents with modern and improved water supply infrastructures.

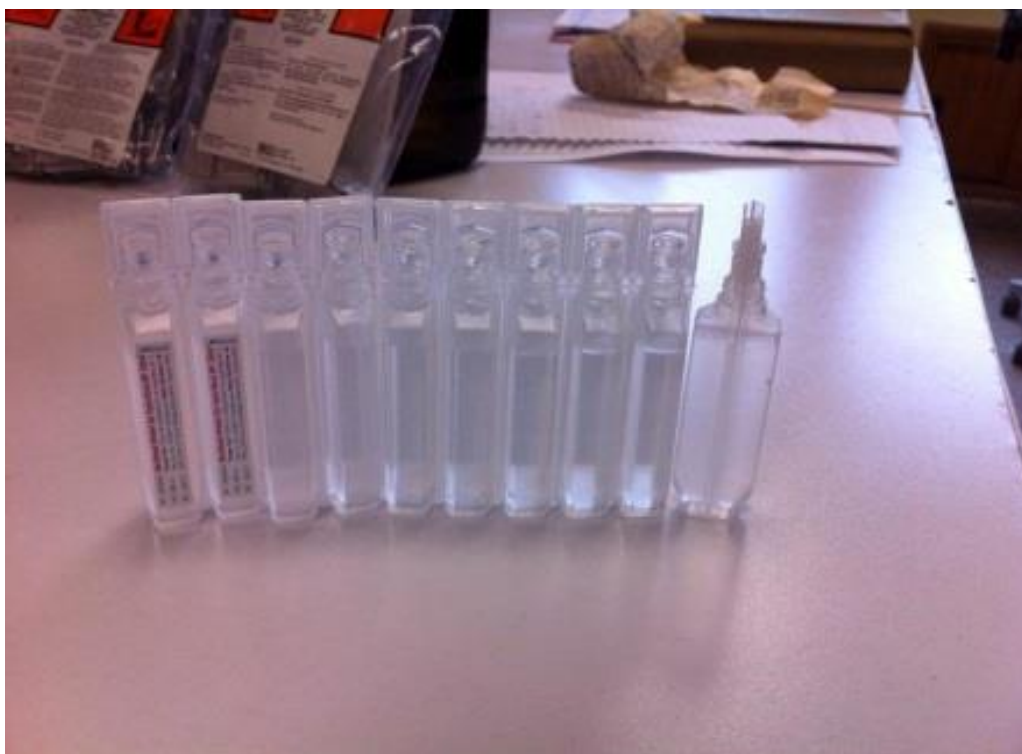
Figure 2.4: Deionized water used to check the effectiveness of instruments and reagent powder pillows in the AAWSA laboratory.

To do this, deionized water was bought from a pharmacy for the preparation of reagent blank. This measures the proportion of the result that is contributed by the reagent. All reagents and instruments used in the AAWSA laboratory were tested and checked for their effectiveness using the deionized water (Figure 2.4). All reagent blank results obtained from the instruments in the AAWSA laboratory were very small which was expected from deionized water. An exceptional result was found for the NitraVer® 5 Nitrate reagent powder pillow.

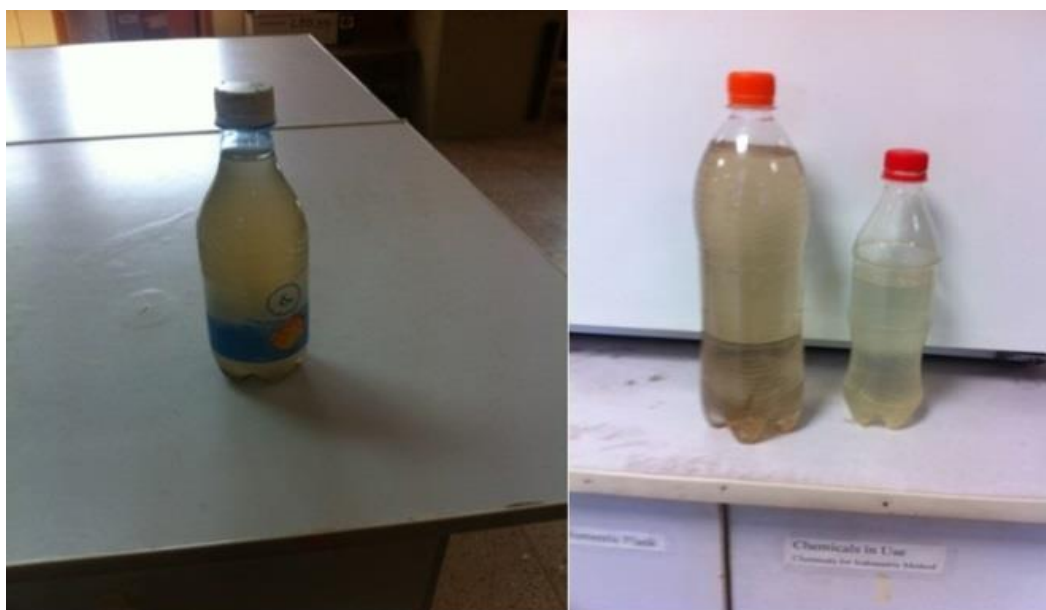
Figure 4.1: Household tap water samples collected and provided by customers, after supply interruption and reinstatement events.

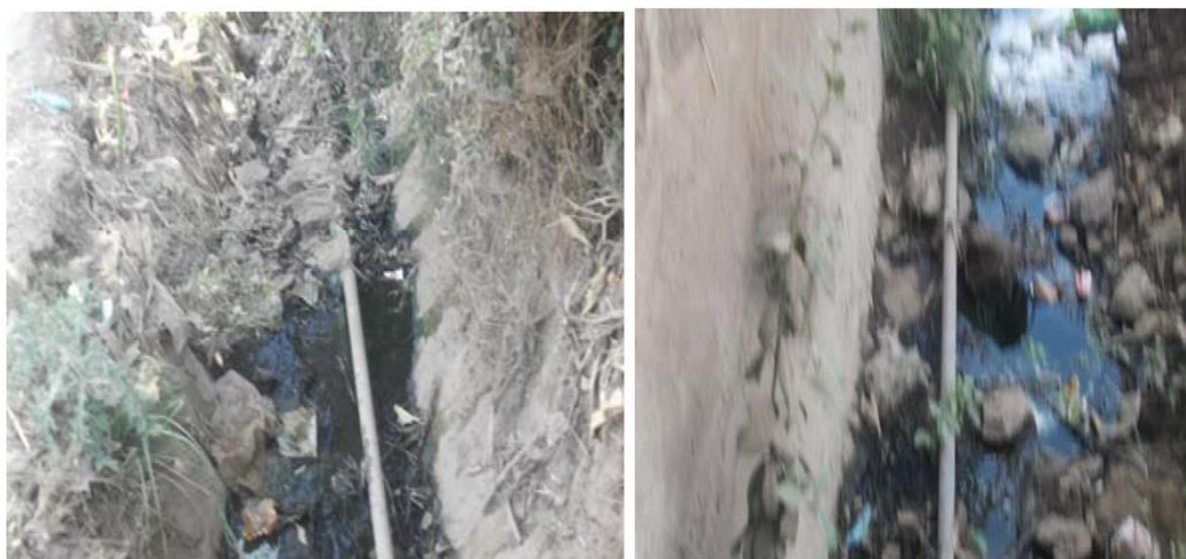
Source: (Birhanu, 2007)

Figure 4.2: Water supply pipelines cross-connected with sewerage lines. Pipes are covered with solid liquid and wastes

It has also been observed that the water supply distribution systems in most slum areas in Addis Ababa City are old, leaky and corroded. It is also common for the water supply system to be cross-connected with sewerage lines Addis Ababa (Figure 4.2).

As summarised in Figure 4.6, there is a strong relationship between the condition of the water supply distribution system (pipelines age, corrosion, leakages and pipeline cross-connections) and the environment where the pipelines are laid (Figure 4.2 and Figure 4.3). In this study, it was observed that the condition of the pipes combined with unhygienic environments and intermittent water supply adversely affects the quality of household drinking water in W-6 and the wider Bole subcity of Addis Ababa. There is strong evidence for water quality deterioration and non-compliance with the drinking water standards. This is a result of the supply disruption and intrusion of contaminants. This was found in all tap water samples collected after supply interruption and reinstatement events.

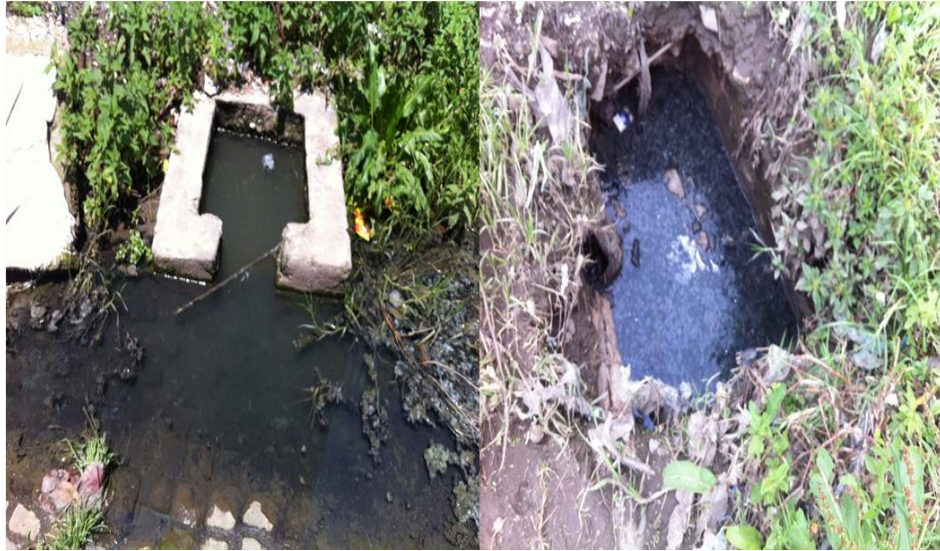
Source: Photo taken from W-6

Figure 4.3: Drainage sites filled with liquid waste generated by household residents.

There is no proper management of solid and liquid waste in Addis Ababa. Sewerage lines are often used for the disposal of wastes generated by the residents of the city (Figure 4.3). This also adversely affects the household drinking water quality of Addis Ababa.

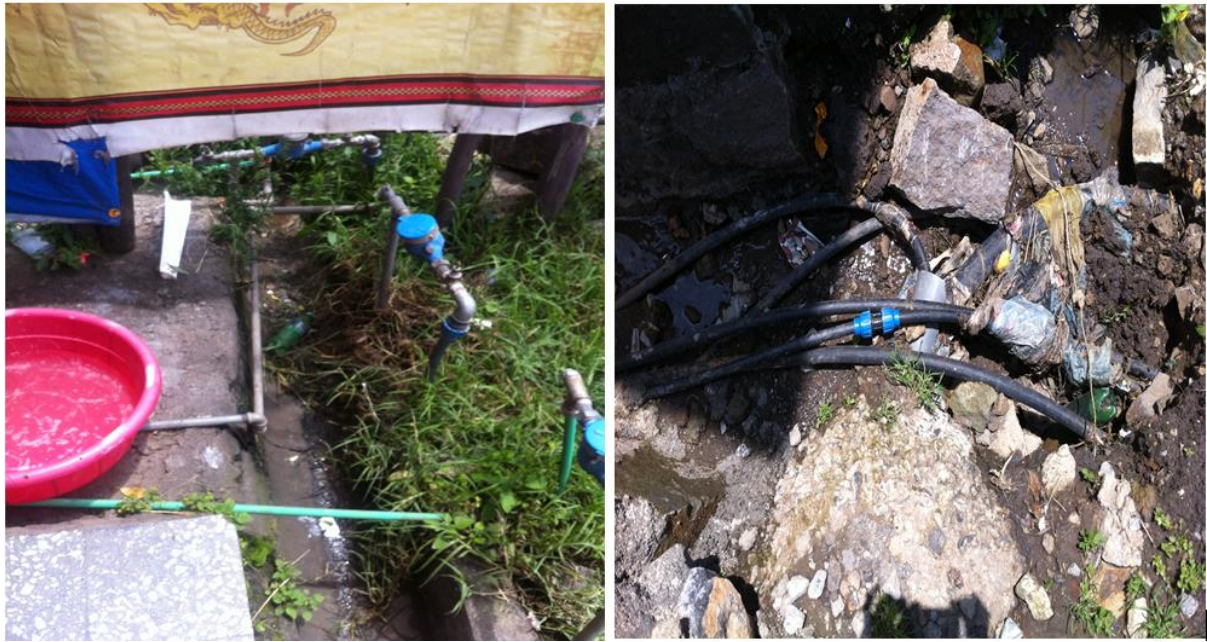
Figure 4.4: Water supply pipelines lay along drainage lines. These lines are exposed to the environment.
